**REPORT OF THE
NATURAL MEAN HIGH WATER ELEVATION
OF SPOFFORD LAKE
CHESTERFIELD, NEW HAMPSHIRE**

**Prepared for the
New Hampshire Department
of Transportation
Reference Project #13597**

**July 1, 2013
Revised 7/09/2013**

Prepared by:
Timothy F. Bernier, LLS, CWS
T. F. Bernier, Inc.
39 Warren Street
Concord, NH 03301

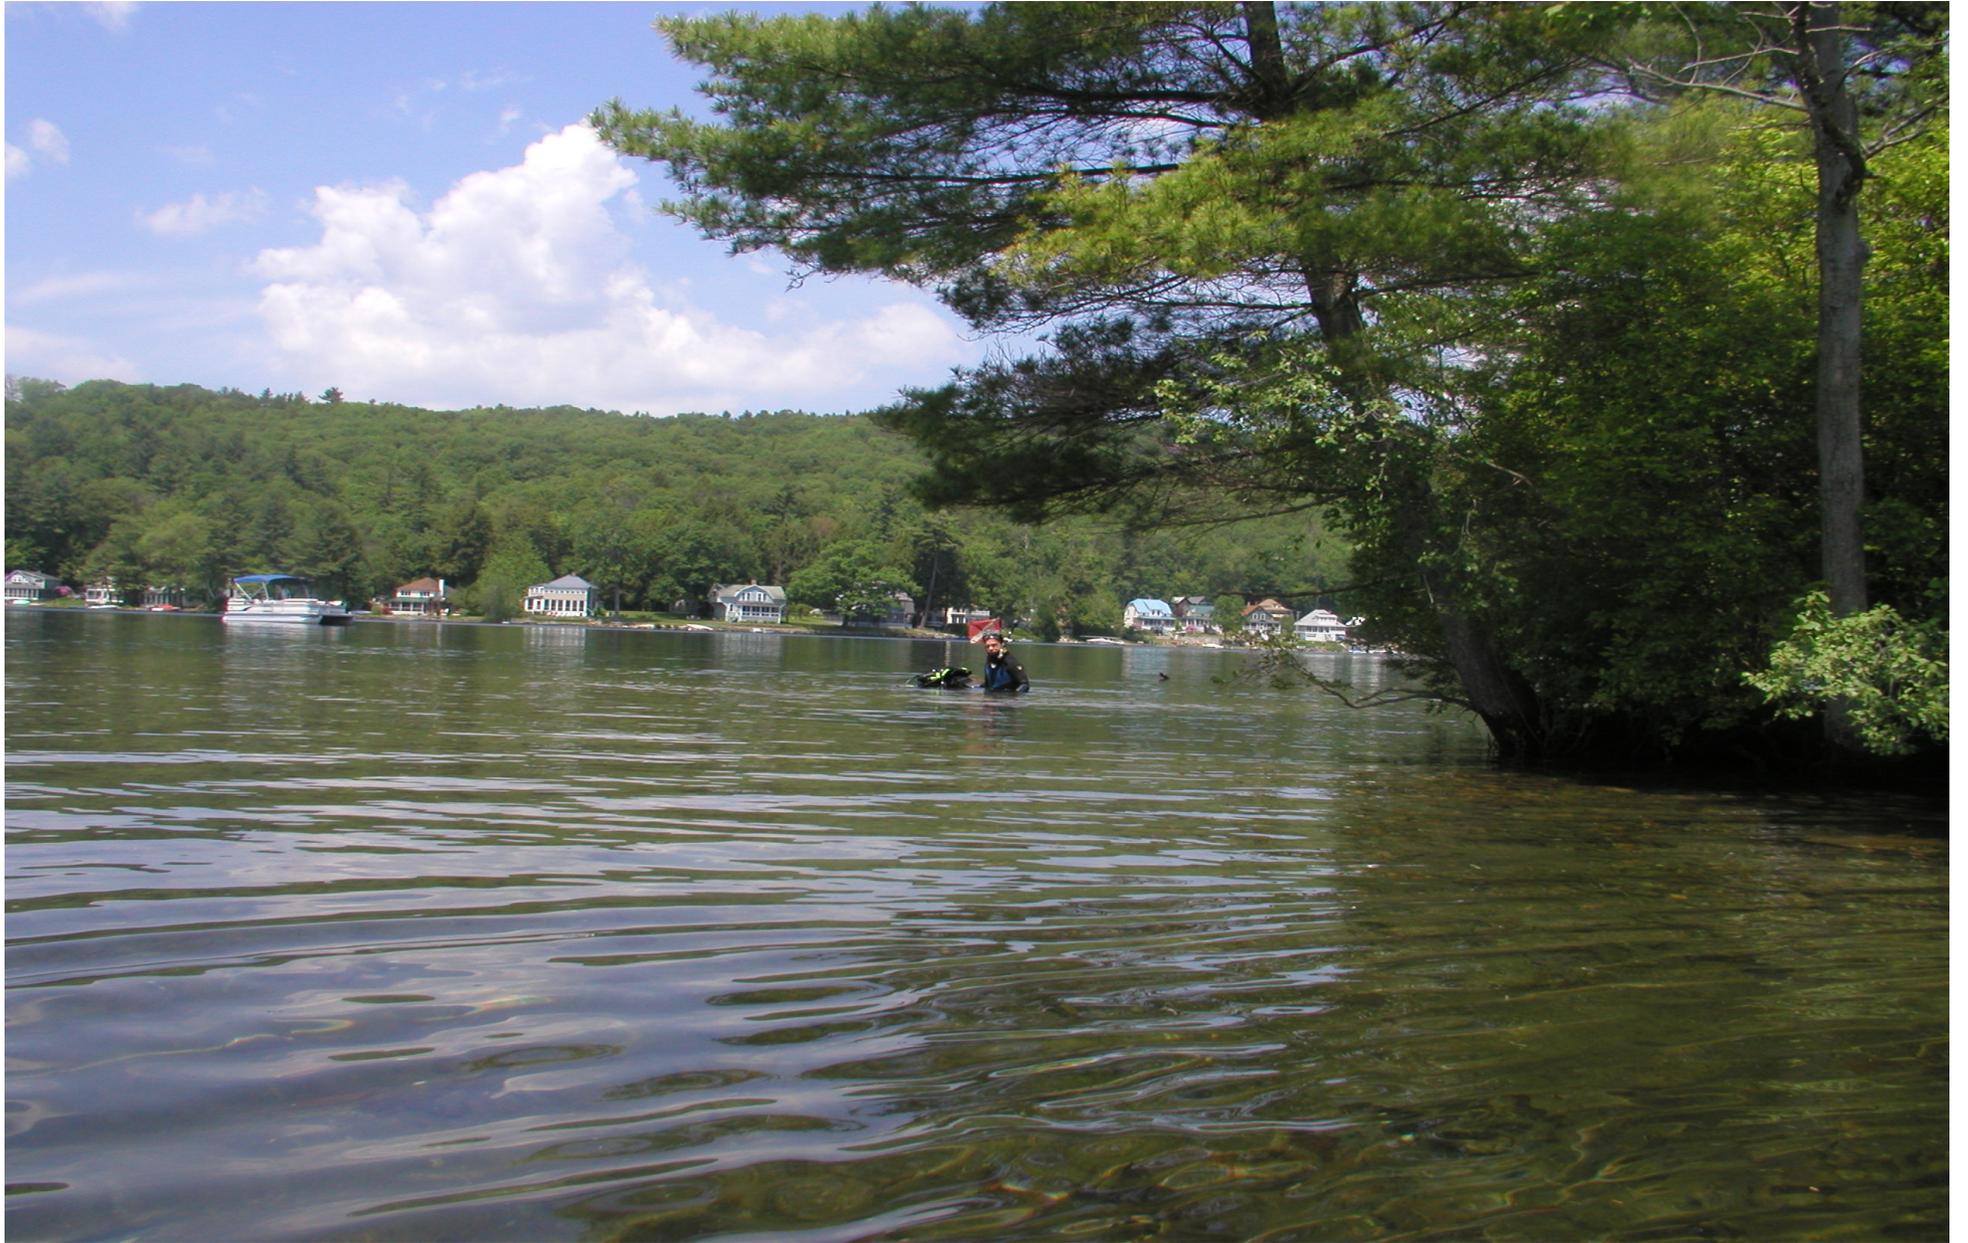
Photo 1

28. Despite extensive searching by boat, chest waders, snorkeling and scuba diving no evidence of stumps were found between the current shore and elevation 700.

First Photo..... Diving for submerged evidence south end Pierce Island

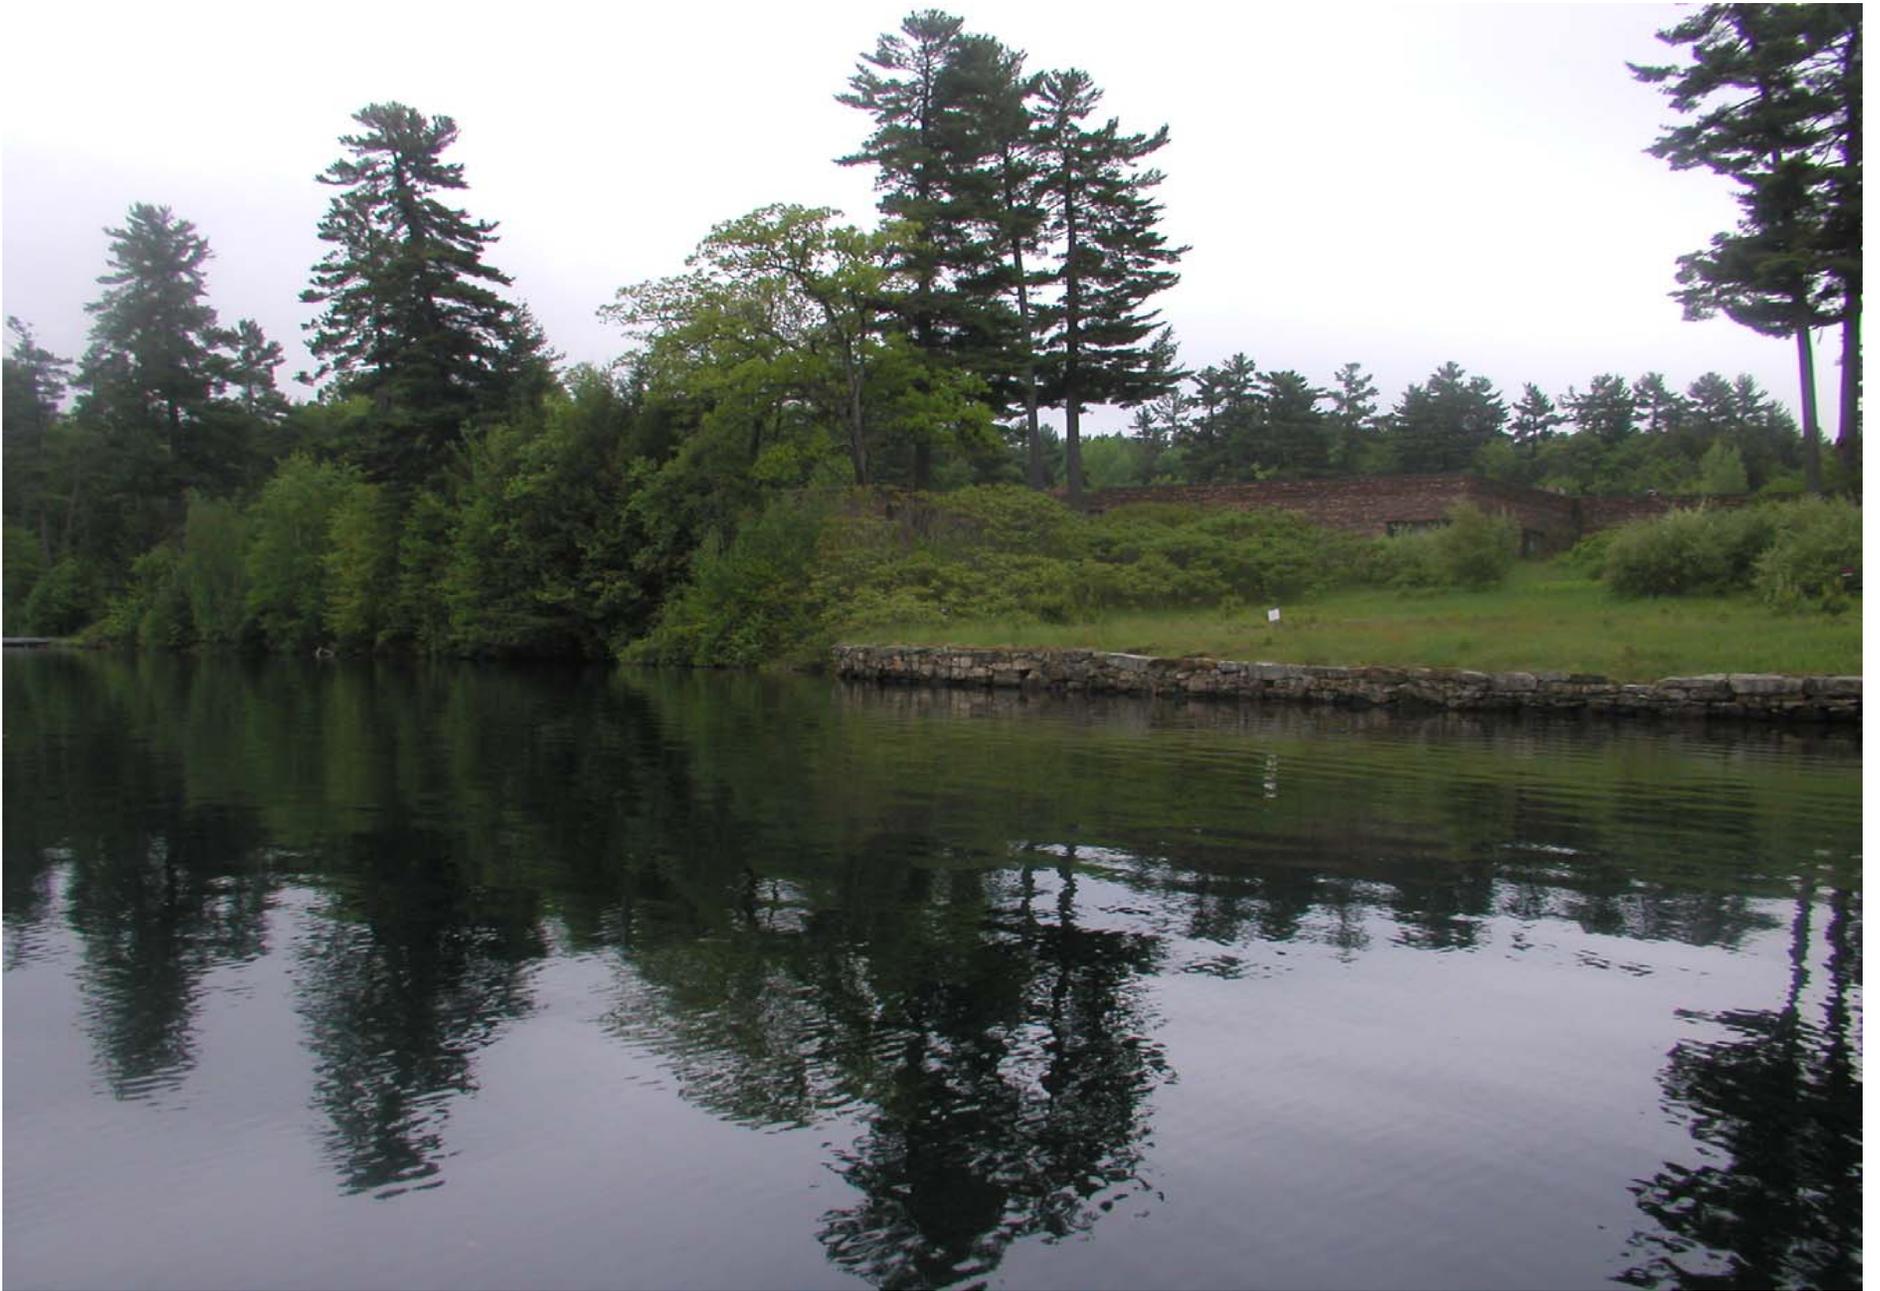
Photo 2

26. A visual inspection of the shore line conducted in May 2013 showed a large number of stone, stone and mortar, and concrete retaining walls along the shore with some found to be over 100 years old. These walls are typically installed to protect otherwise unprotected land from the erosive action of the lake. It was also observed that the shoreline had no naturally occurring shore. In nearly all undeveloped locations around the lake the water level was at the tree line. In a lake the size of Spoffard Lake normal ice and wave action should produce a natural rock shore or span of beach to buffer the upland vegetation from forces associated with the surface water.

Second Photo 100 year old stone and mortar retaining wall

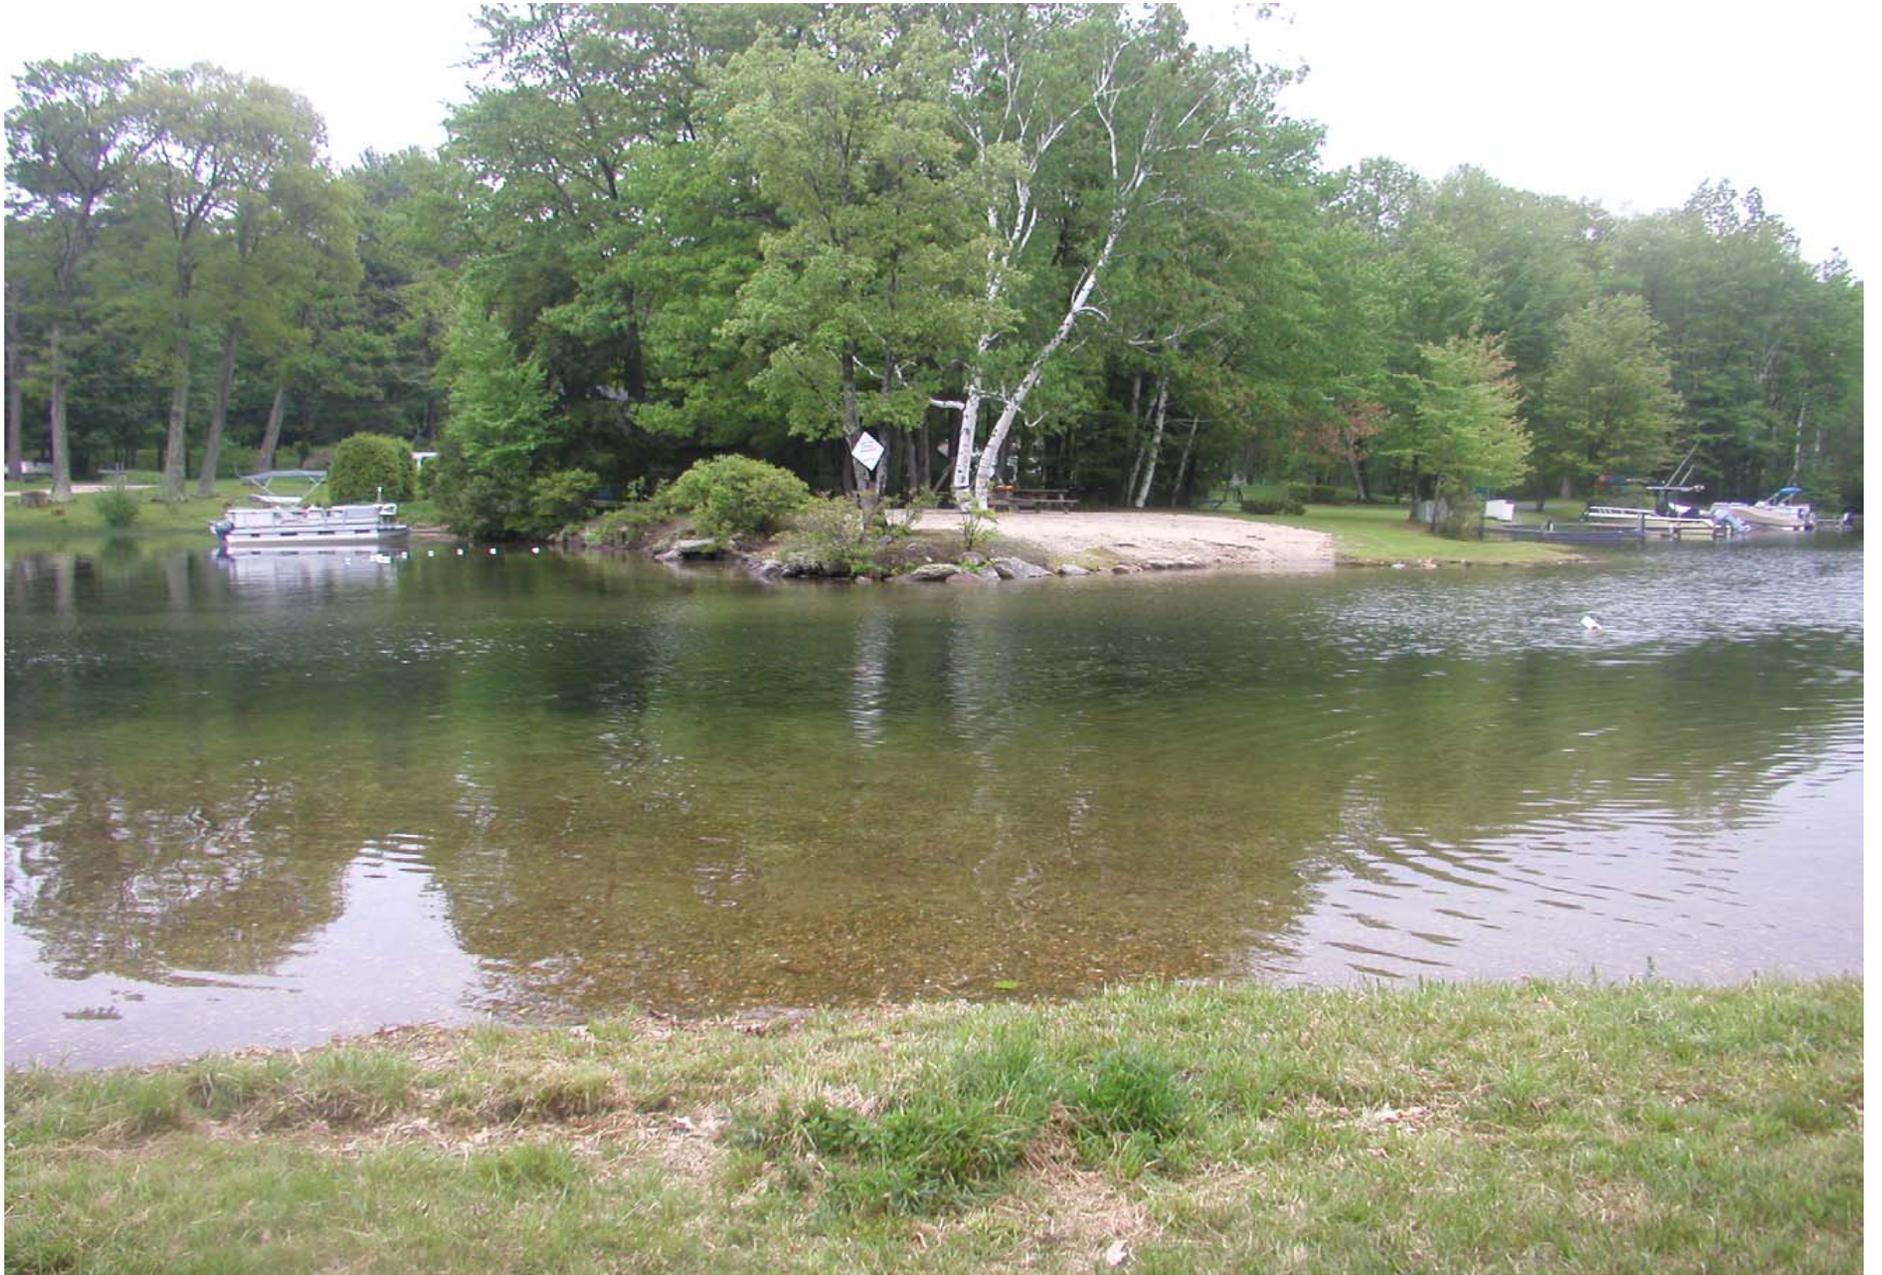
Photo 3

18. In 1965 or 1966 The Outlet was dredged and significantly widened. The current width of The Outlet at the lake is 96 feet wide.
19. During the winter of 1977, 78 complaints were made to the Chesterfield Selectman and the Water Resources Commission that the water elevation was being maintained too high and causing ice damage to docks and homes.

29. We completed a cross section of The Outlet where it begins at the lake a low elevation of 711.5' (NAVD88) was observed in May of 2013. However this location was altered in 1999 when the spillway was replaced. This location was used as a coffer dam location in 1999 while the spillway was reconstructed. A cross section of the same area completed by SVE Associates in 1998 had a bottom elevation of 713.4' (NAVD88).

Third Photo Point where the lake drains into The Outlet 2013

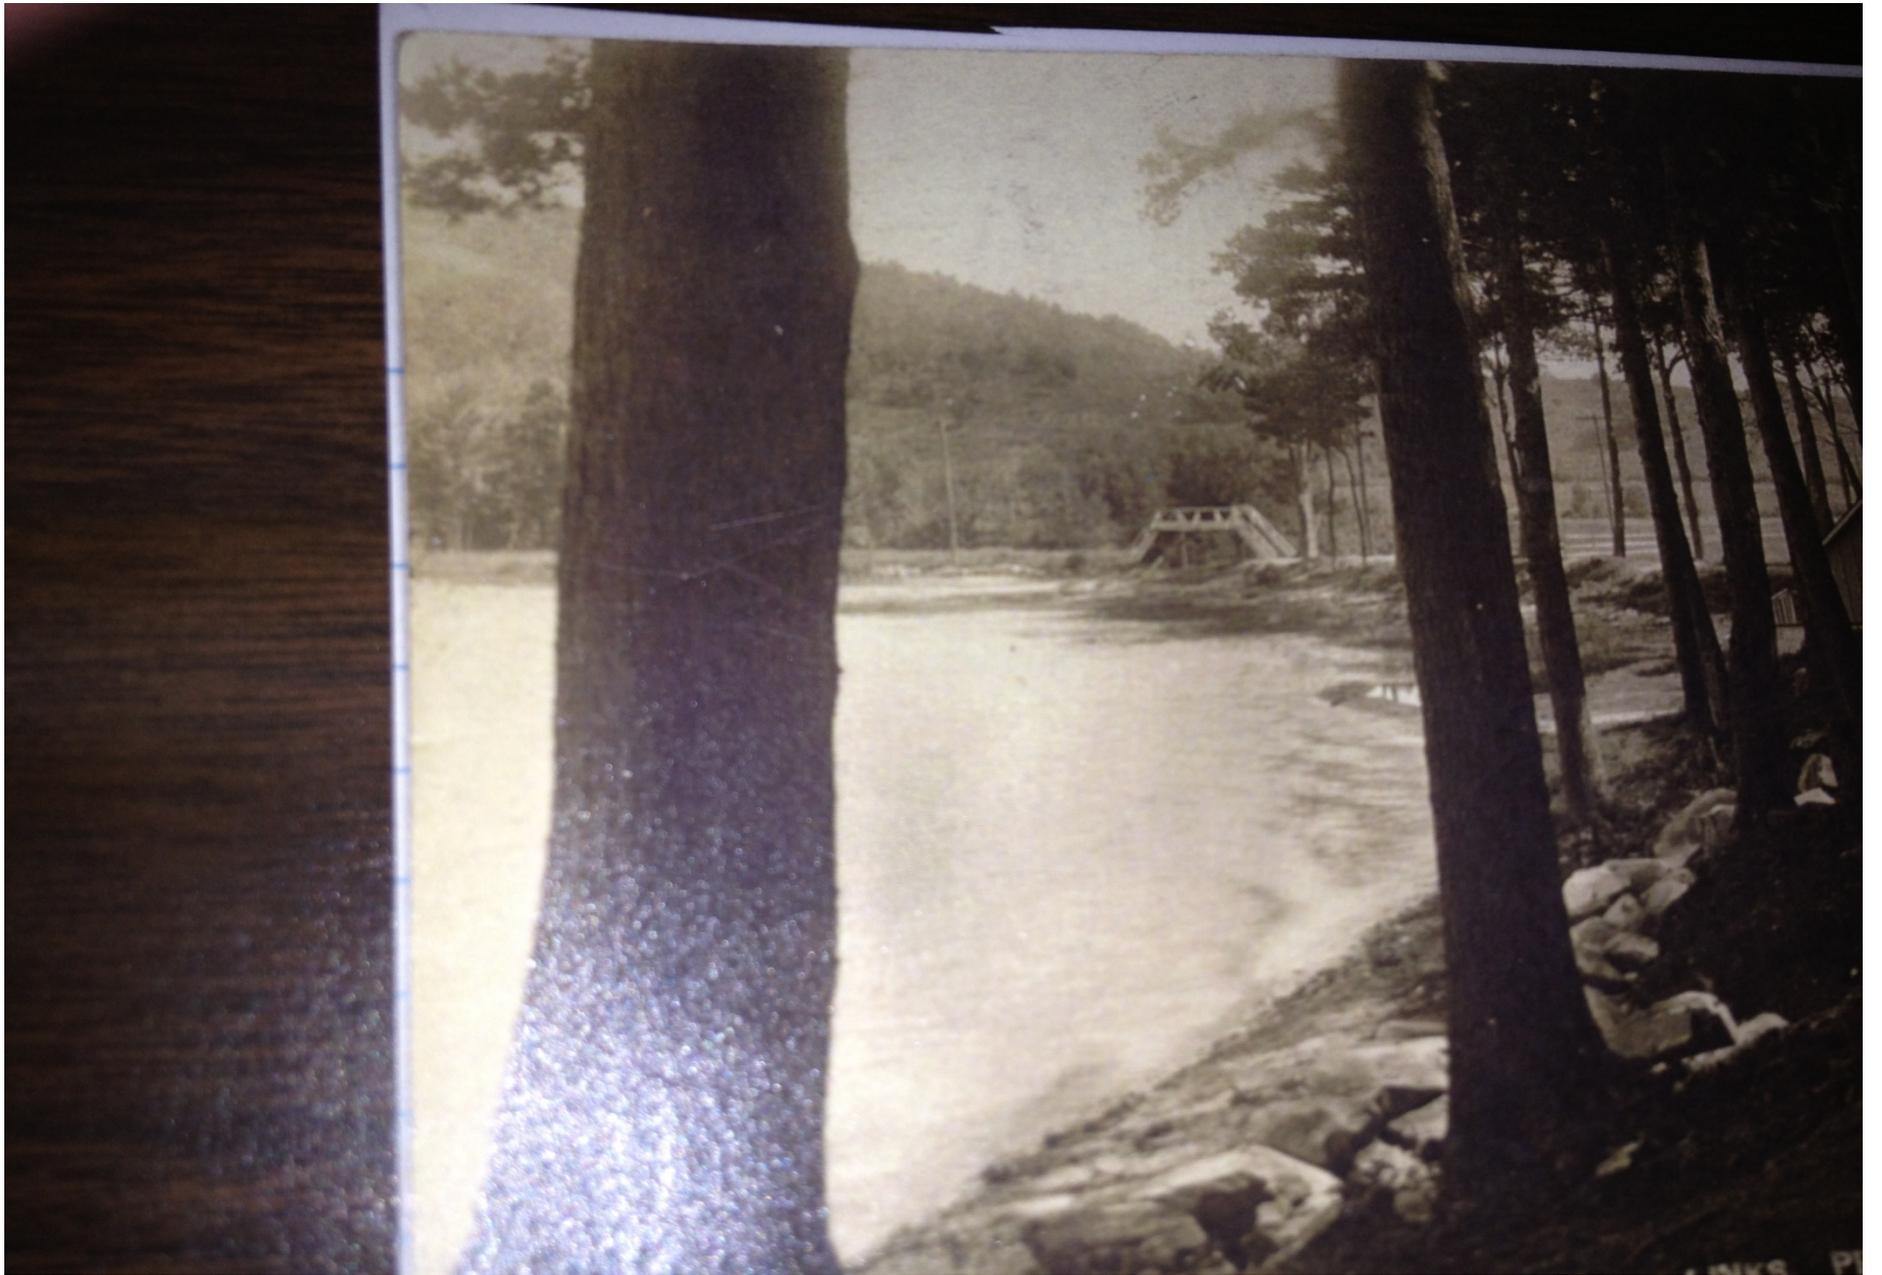
Photo 4

11. Based on photographs and surveys around the turn of the century the width of The Outlet at the point the lake drains into it was no more than twenty feet and possibly as little as ten feet wide.

Fourth Photo..... A foot bridge over the same point as third photo 1900±

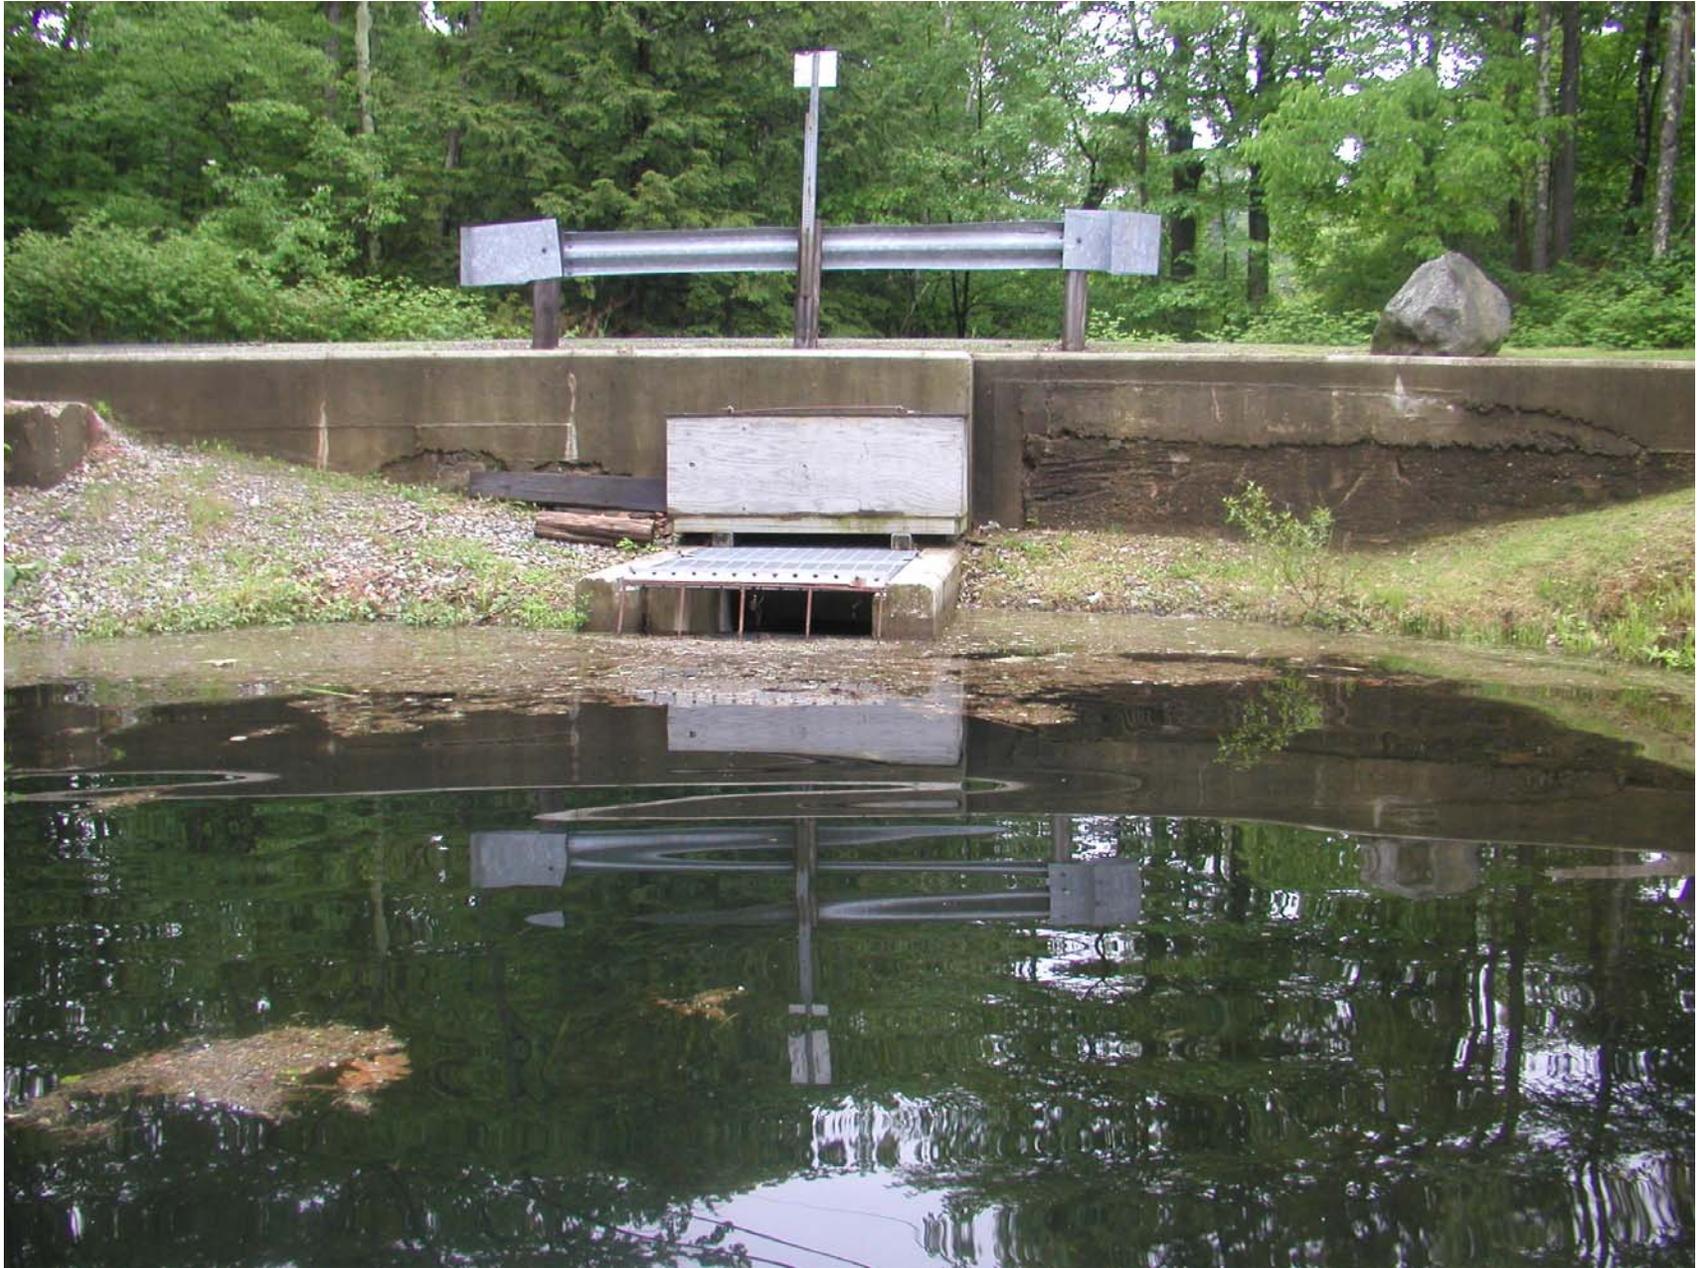
Photo 6

24. The reconstruction of the spillway was completed in 1999. Per a telephone conversation with the Chesterfield Highway Department no blasting was done in the construction of

- the dam. Jack hammers were used to remove small amounts of ledge and the inlet was poured concrete formed around ledge. The gate house was removed at this time.

Sixth Photo..... Spillway 2013

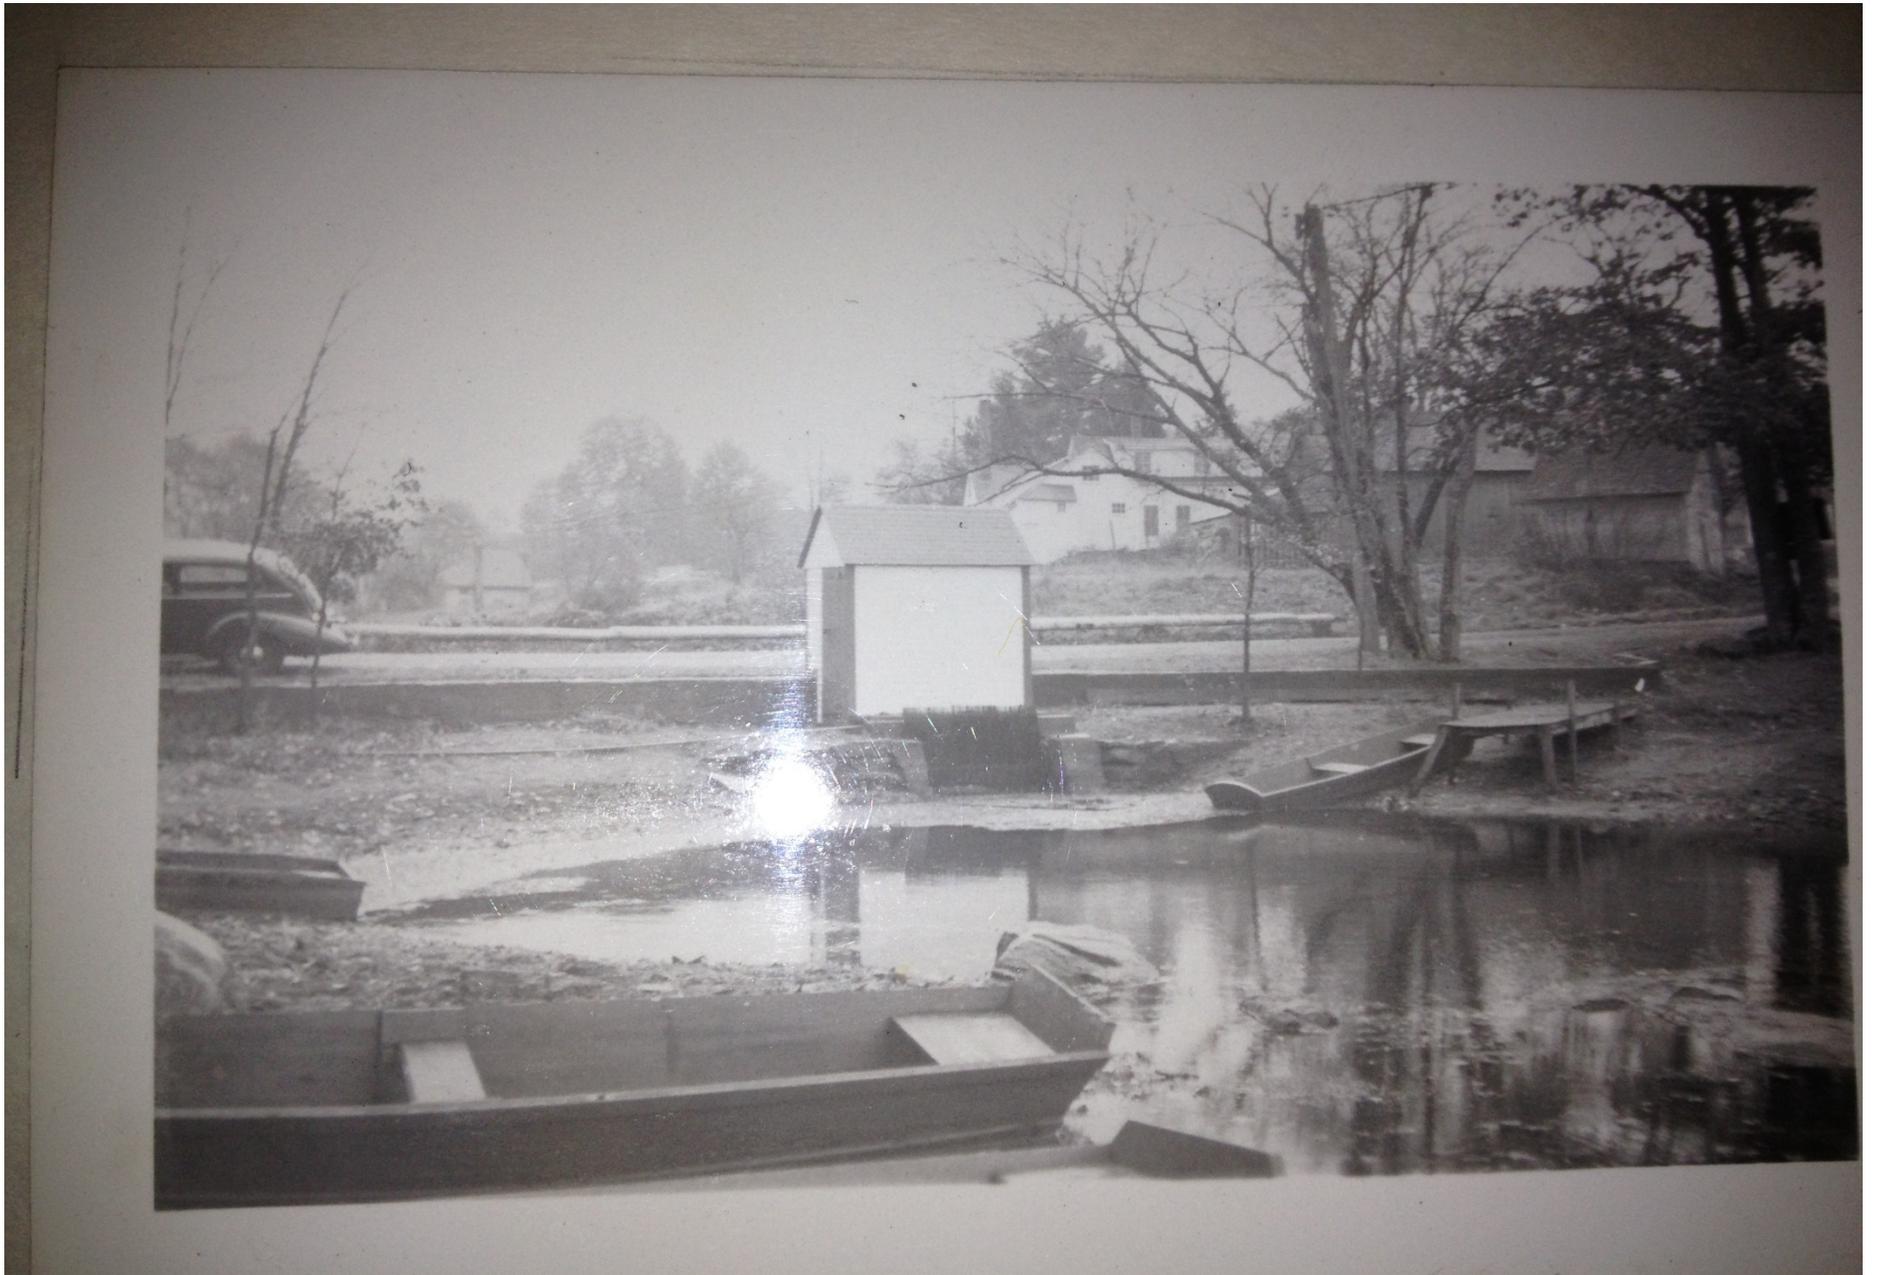
Photo 7

Seventh Photo Spillway and outlet 1937
